### Bonded Fibre Reinforced Polymer Strengthening in a Real Fire

# **Bonded Fibre Reinforced Polymer Strengthening in a Real Fire**

T.J. Stratford<sup>\*</sup>, M. Gillie, J.F. Chen and A.S. Usmani

Institute for Infrastructure and Environment, School of Engineering, The University of Edinburgh, UK.

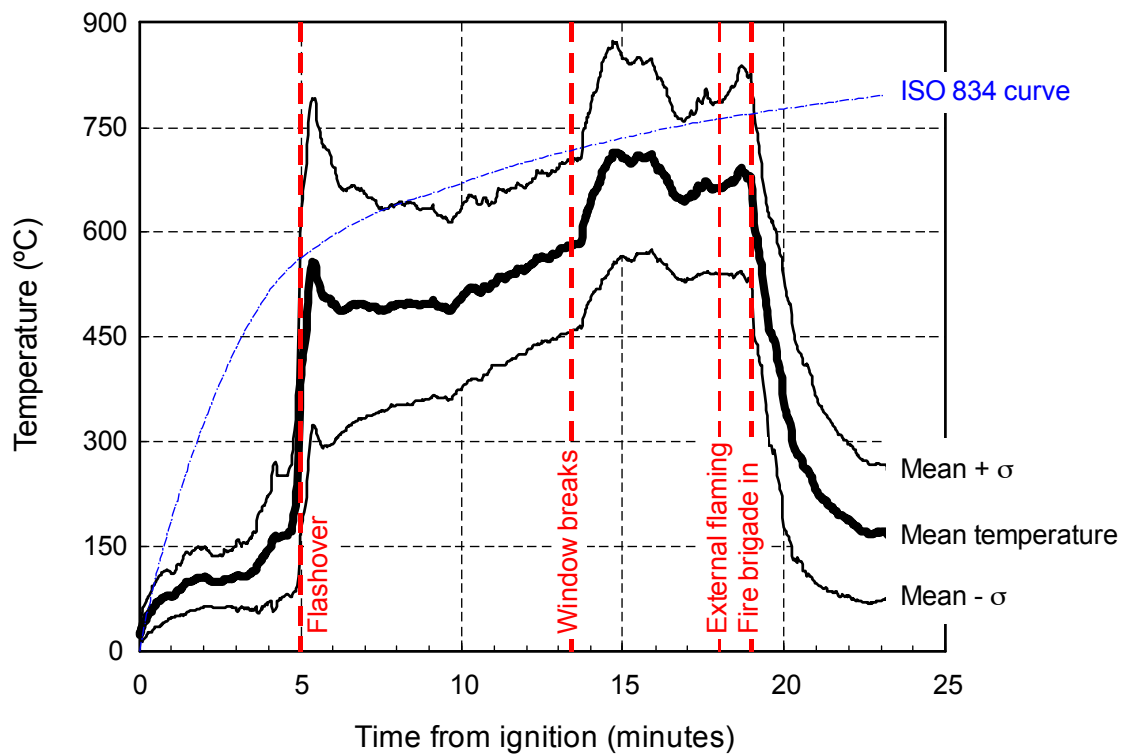
Figure 7: Development of gas phase temperatures in the Test 1 compartment (mean  $\pm$  1 standard deviation).

Figure 7 shows the Test 1 fire development in terms of the gas phase temperatures measured within the compartment. It shows the mean temperature from the 240 thermocouples that recorded the 3D temperature field within the fire compartment. Two further curves plot the mean temperature plus and the mean minus one standard deviation to indicate the spatial variation in temperatures through the compartment. The ISO-834 time-temperature curve is included as a benchmark against which the experimental results can be compared. Figure 7 shows the three main phases of the fire:

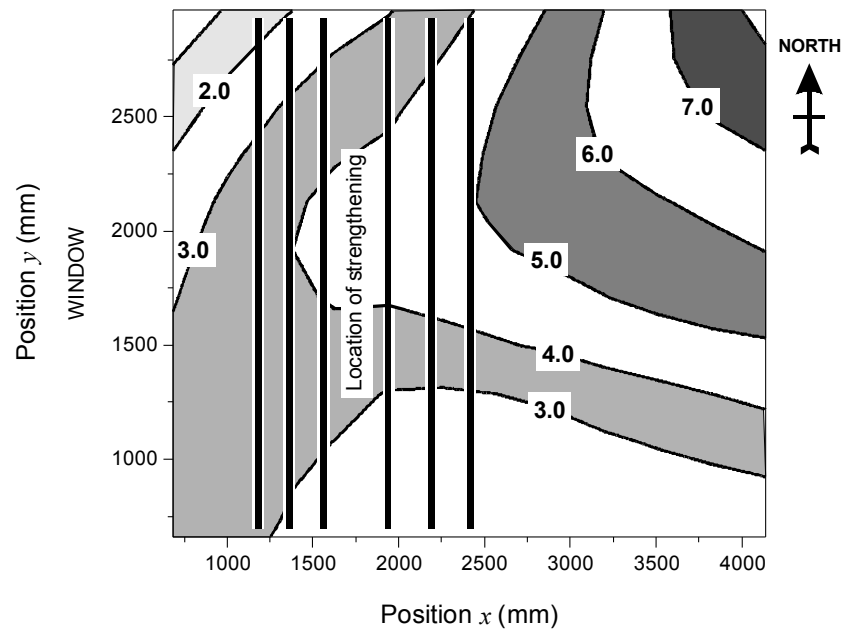
Figure 8: Heat flux incident on the ceiling in the Test 1 compartment ( $\text{kW/m}^2$ ), 4 minutes after ignition.

The peak heat release rate during the fire was 800kW. The heat flux incident upon the ceiling of the compartment at four minutes after ignition is shown in Figure 8. This illustrates the spatial variation in heat fluxes both across the room and across the region of FRP strengthening.
